REPORT ON THE REHABILITATION  
OF THE GENERAL A.G. JENKINS HOUSE  
GREENBOTTOM WEST VIRGINIA

OCTOBER 1988

PREPARED FOR THE  
US ARMY CORPS OF ENGINEERS  
HUNTINGTON DISTRICT

Consultant:  
Michael Gioulis  
Historic Preservation Consultant  
612 Main Street  
Sutton, WV 26601

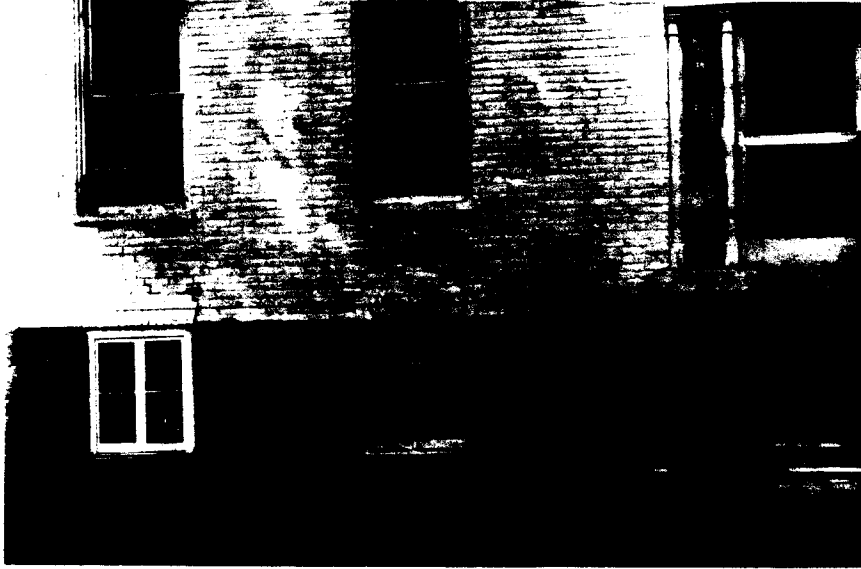
3

1. Front, North elevation
2. Rear, South elevation. Note addition on right
3. Detail of brickwork on front elevation
4. Detail of deteriorated brickwork at chimney
5. Detail of trim in First floor Parlor. Note non original base.
6. Base where previous heating system occurred, typical of all rooms.
7. Deterioration of sills
8. Detail of panel in sidelights at front door
9. Mantel in First floor parlor, ca. 1930
10. Mantel in Second floor west Bedroom, probably original model for Parlor mantel
11. Door in Second floor west Bedroom, original
12. Dormer in Attic
13. Kitchen in addition
14. Basement room typical of two
